ELECTRIC SHOWERS: FREQUENT FAILURES DUE TO TEMPERATURES OF CONNECTIONS ABOVE LIMITS

Good reading for designers of switchgear IEC 61439 and IEC 62271

Author:
 Sergio Feitoza Costa
 COGNITOR – Consultancy, Research and Training Ltd.

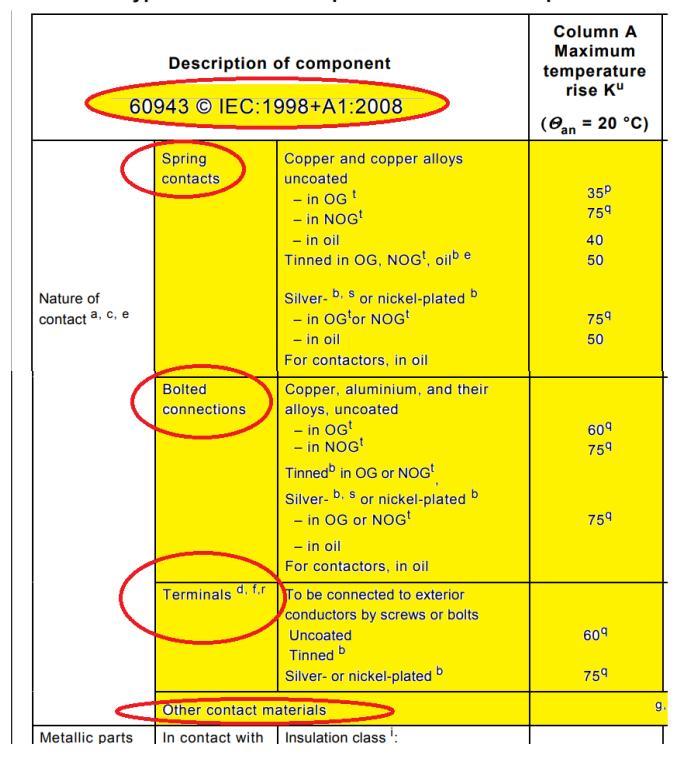
Table 6 – Typical values of temperature rise and temperature limits*

To be approved in the test the temperature rise shall remain below the limits for that materials like in this table (from IEC 62271-1 or IEC TR 60943).

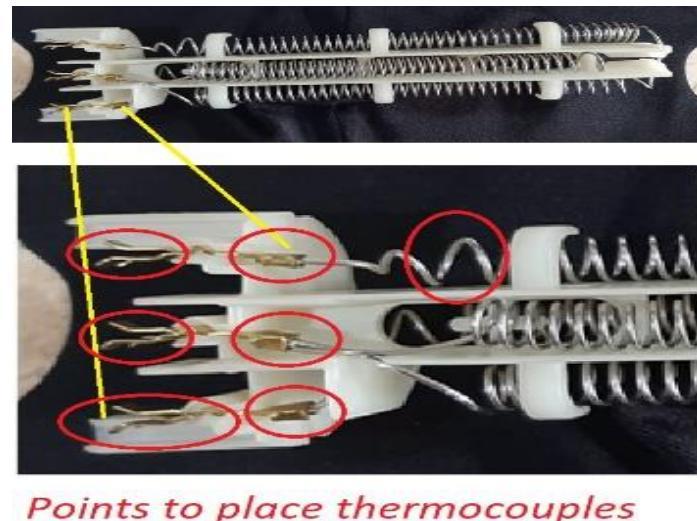
Points to place thermocouples during temperature rise test of electric shower

The only thing to do is to add in the temperature rise test, the measurement of the temperature rises of the connection like in the photo.
